PEACE VALLEY DAM
BUCKS COUNTY, PENNSYLVANIA
NATIONAL I.D. NO. PA 00790

6 PHASE I INSPECTION REPORT
NATIONAL DAM INSPECTION PROGRAM,
Peace Valley Dam (ID PA-00790), Delaware
River Basin, North Branch Neshaminy Creek,
Bucks County, Pennsylvania. Phase I
Inspection Report.

PHASE I INSPECTION REPORT
NATIONAL DAM INSPECTION PROGRAM
PEACE VALLEY DAM
NATIONAL ID # PA 00790
DER ID #9-169

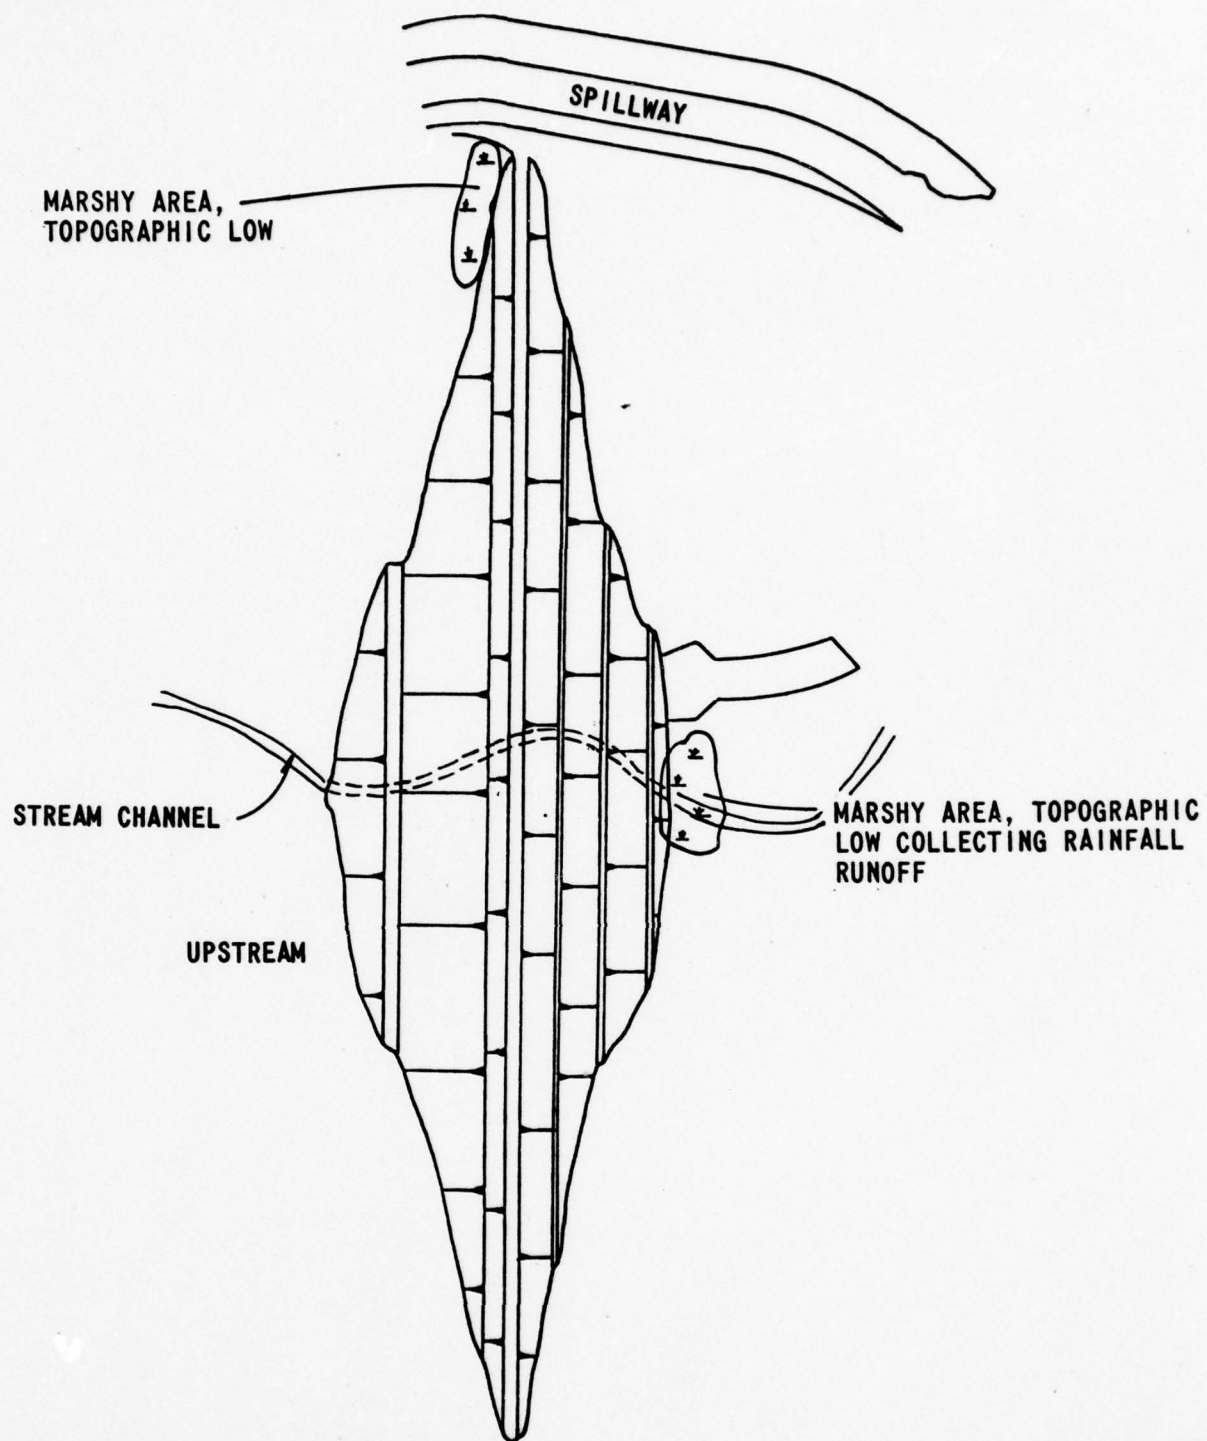
SHEET 5a OF 11

As discussed in Appendix B, a marshy area was noted on the right side of the SAF stilling basin in the vicinity of the old streambed channel. This area is a topographic low which prevents drainage from the toe of the dam. A careful inspection of this area and marshy zone downstream did not reveal evidence of springs or uncontrolled seepage. This area should be drained and monitored for embankment seepage.

All abutments were in good condition. Some standing water was observed on the upstream side of the dam at the toe near the left end of the embankment. See sheet 5a of 11.

None observed, but standing water was observed as described above and on the downstream toe where the old stream channel previously existed. See sheet 5a of 11.

a. Facilities. It is recommended that the area of standing water in the vicinity of the old stream channel be regraded and drained into the creek downstream. Subsequently, this area should be cleared and inspected for seepage. If seepage is observed, the flow rate should be monitored and the turbidity checked.
